Performance Charge Pipe Kit Part Number: 17-148

Toyota 2022-2024 Tundra 3.4L Turbo Toyota 2023-2024 Sequoia 3.4L Turbo

Installation Instructions

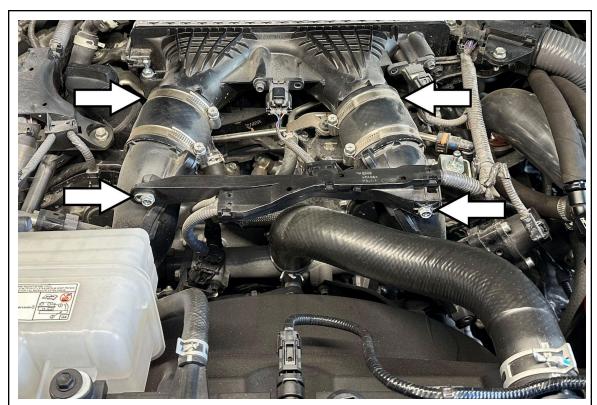
1. Turn the ignition OFF and disconnect both of the vehicle's battery's negative cables . If the engine has run within the past two hours let it cool down.

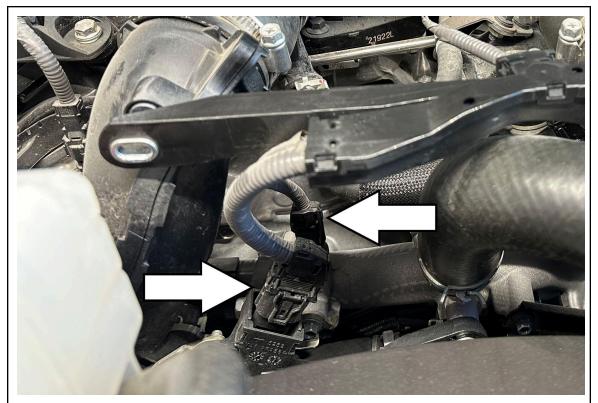
2. Remove the engine cover. Loosen the two upper charge pipe hose clamps and unbolt the two harness mounting bolts.

3. Disconnect the two harness plugs shown in the picture above.

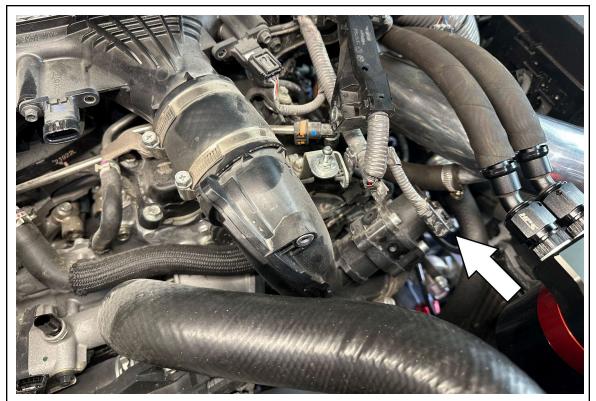
4. Disconnect the two additional harness plugs shown in the picture above and clear them towards the driver side.

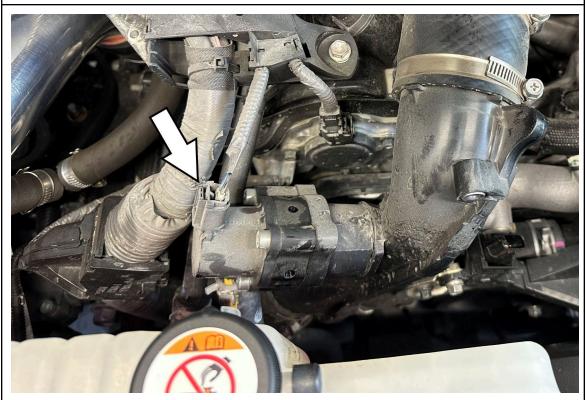
5. Disconnect the harness connected to the blow off valve on the driver side.

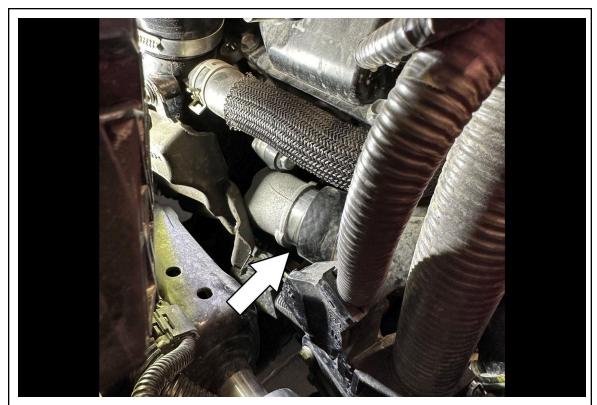
6. Disconnect the harness connected to the blow off valve on the passenger side.

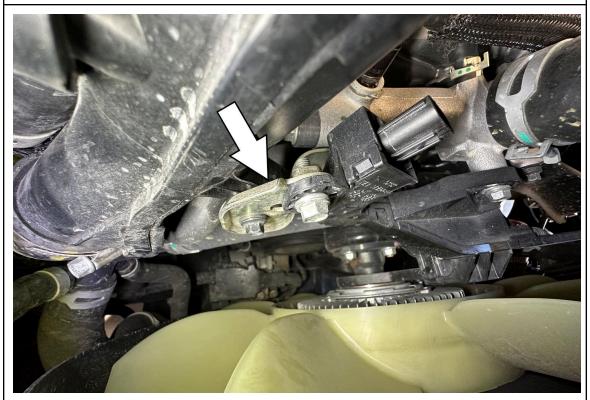
7. Remove the turbo outlet hose clamp on the passenger side.

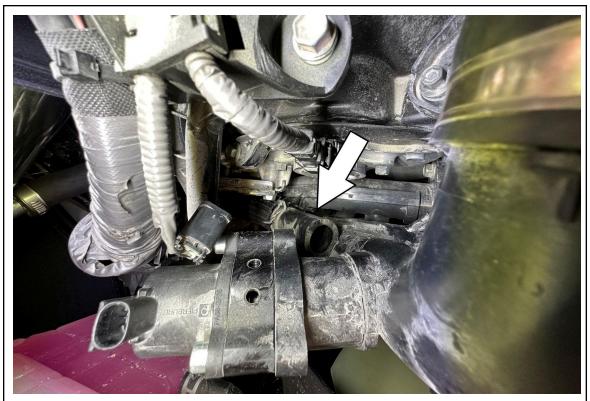
8. Remove the two mounting bolts and mounting bracket on the passenger side charge pipe.

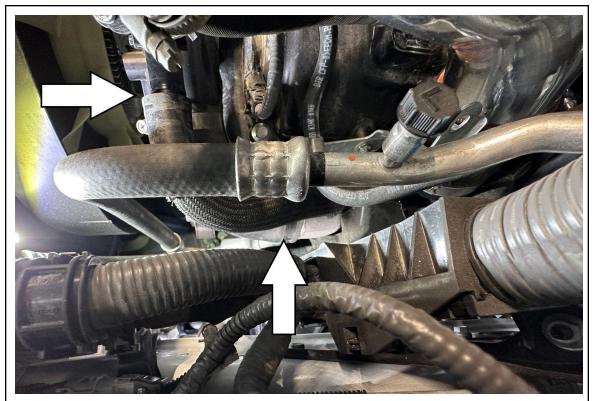
10. Remove the driver side charge pipe bracket by removing the two mounting bolts.

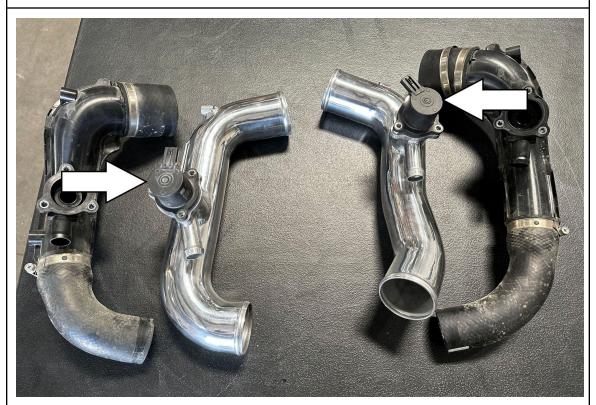
11. On the driver side, remove the turbo outlet hose and disconnect the recirculation hose. Then, remove the charge pipe from the truck.

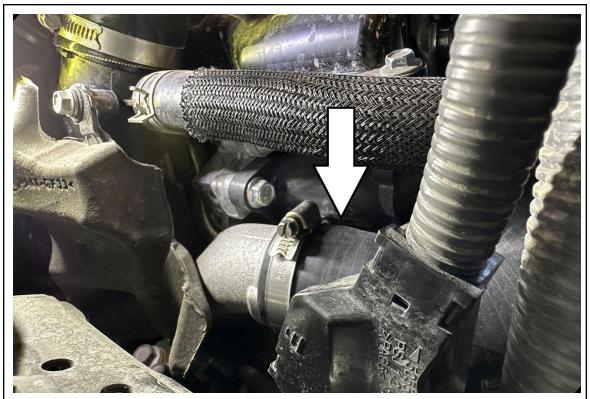
12. Remove the blow off valves from the stock charge pipes and install them onto the HPS charge pipes using six of the provided M6 bolts.

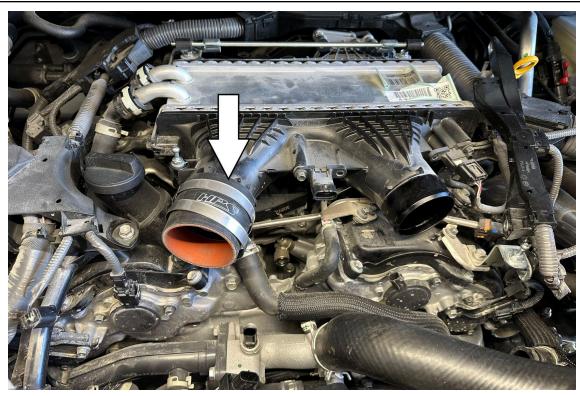
13. Install the provided 45 degree reducer coupler onto the passenger side turbo outlet using one provided 60mm-80mm embossed hose clamp and one provided 40mm-60mm embossed hose clamp.

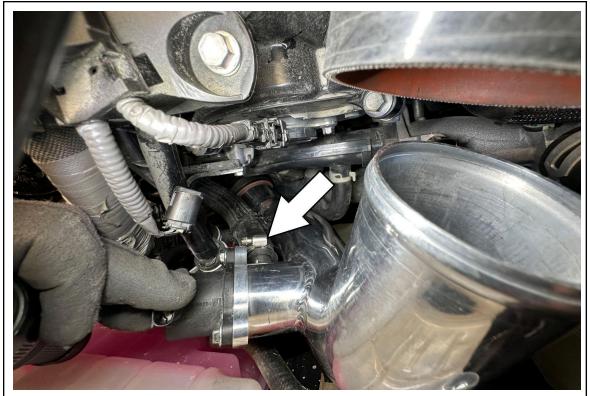
14. Install the 2.5" coupler onto the passenger side intercooler inlet using two of the provided 60mm-80mm embossed hose clamps.

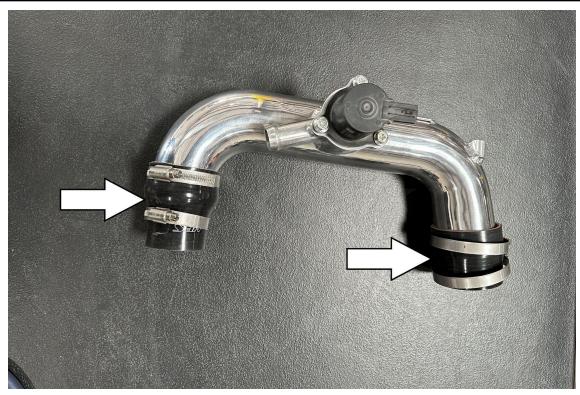
15. Insert the passenger side charge pipe into the 45 degree coupler. Then, reconnect the recirculation hose to the passenger side blow off valve and secure it to the HPS charge pipe using one of the provided 20mm-32mm embossed hose clamps.

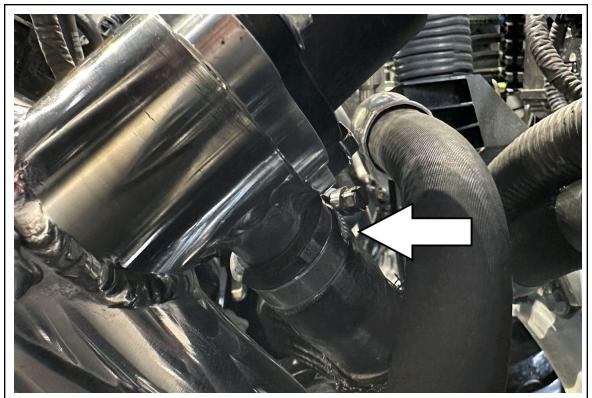
16. Pre-assemble the driver side charge pipe as shown in the picture above using the provided 1.75" to 2.5" reducer coupler and 2.5" straight coupler. Use the other three provided 60mm-80mm embossed hose clamps and one 40mm-60mm embossed hose clamp.

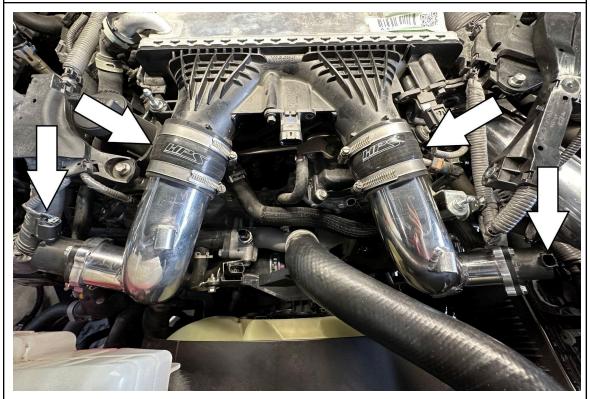
17. Install the driver side charge pipe with the reducer coupler onto the turbo outlet, then reconnect the recirculation hose to the driver side blow off valve and secure it to the HPS charge pipe using the other provided 20mm-32mm embossed hose clamp.

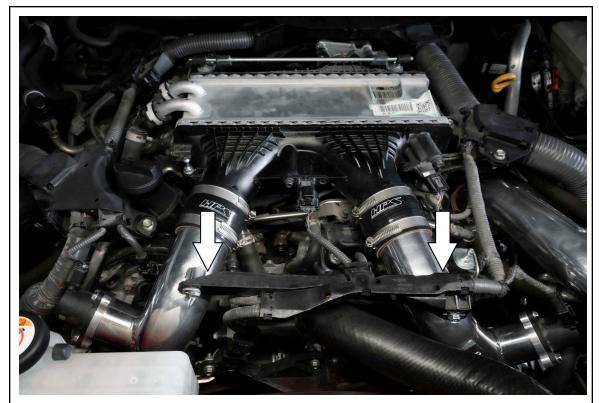
18. Mate the charge pipes to the intercooler and fasten the clamps. Next, reconnect the four blow off valve harnesses.

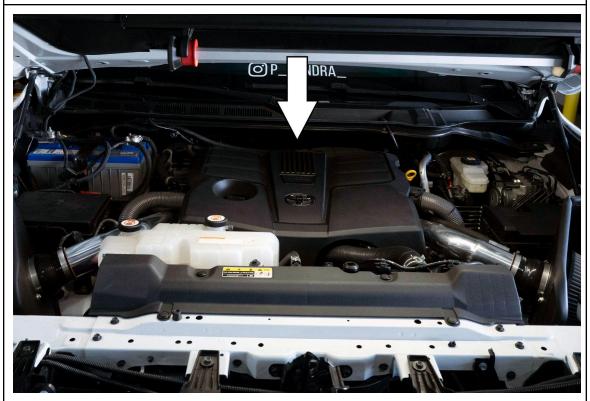
19. Mount the harness to the two charge pipes using the two provided M6 bolts.
