# GMCA428

2015-16 DURAMAX 6.6L DOWN PIPE 3-BOLT FLANGE

50 STATE LEGAL  
CARB E.O. # D-763-2

# MBRP

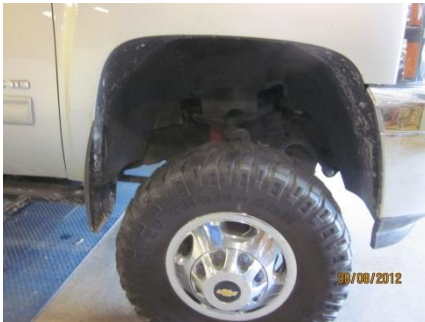
**Figure 1**

1. Remove the passenger-side inner fender.  
**See Figure 1.**  
Note: we also removed the Grille Assembly to prevent damage to it during the removal or installation of the down pipe.
2. The front pipe needs to be temporarily removed. Carefully disconnect all sensors and loosen the four flange nuts on the rearward part of the front pipe. The transmission cross-member will need to be temporarily dropped to remove the front pipe. Remember to support the transmission with a block or jack stand while doing the transmission cross-member removal.  
**See Figure 2.**
3. Remove the hex bolt securing the down pipe to the exhaust manifold. Remove the sensor located just above the hex bolt. The 3 nuts connecting the front pipe to the down pipe can also be removed. Save the hex bolt, nuts and sensor for the installation.  
**See Figure 3.**

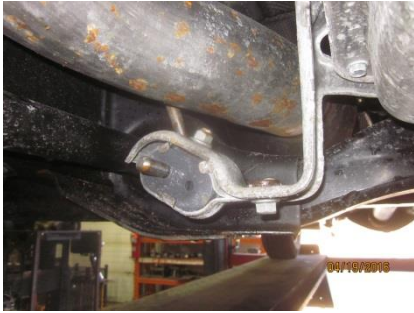
**Figure 4**

4. The front pipe has a hanger mounted to the transmission that will also have to be removed. Remove the bracket from the transmission. **See Figure 4.**

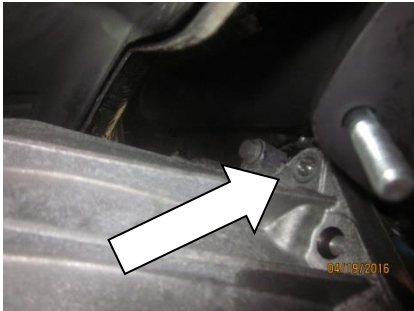
**Figure 5**

5. Remove the combination stud/bolt from the transmission bellhousing just above the locating dowel. It has already been removed in **Figure 5**. This is to allow the clearance necessary to remove the down pipe.
