## TSB-253

### Suzuki Swift Cross Shaft

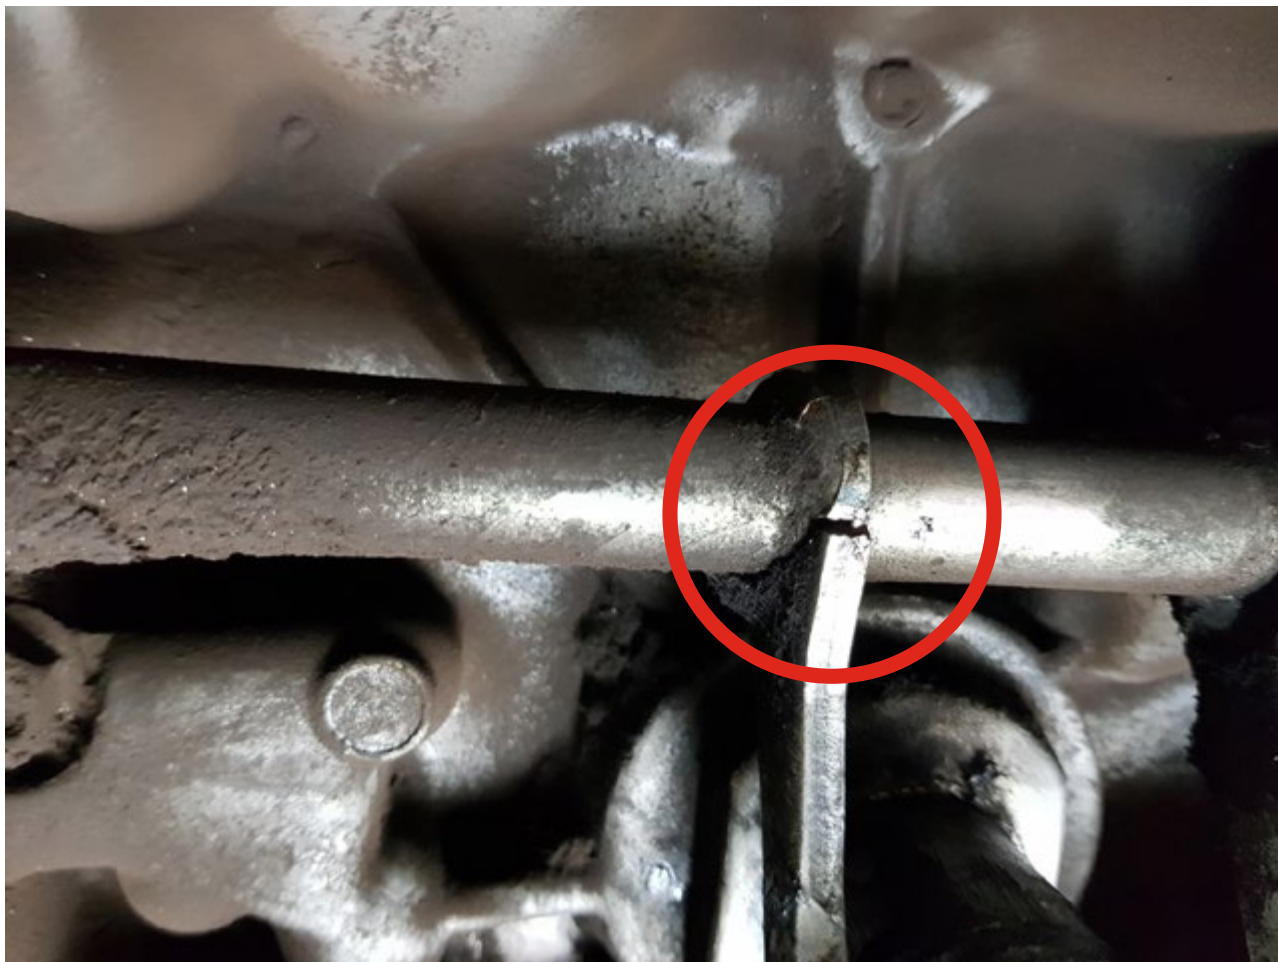
In some Suzuki Swifts, the cross shaft can develop a crack, such as the one shown in the image below.

Any damage to the cross shaft can cause the bearing to run off centre and lead to premature wear on the clutch.

It is therefore highly recommended that all parts of the clutch system are inspected each time the gearbox is removed and any parts that are damaged/ worn are replaced prior to reassembly.

You can purchase a new cross shaft and bushes from your nearest ClutchPro Distributor.

**Cross shaft:** ATFSZ01-CS

**Bushes:** ATFSZ01-CS1, ATFSZ01-CS2
