TSB-TY05

Clutch Release Fork Lubrication for Toyota Hi-Lux

In relation to vehicles: Toyota Hi-Lux KUN16/26 and Toyota Hi-Lux GGN15/25

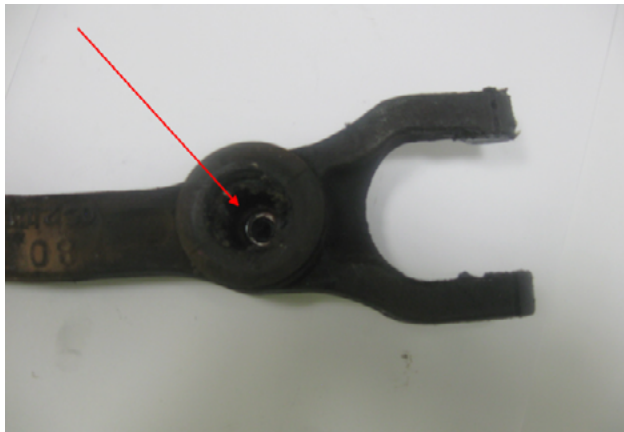
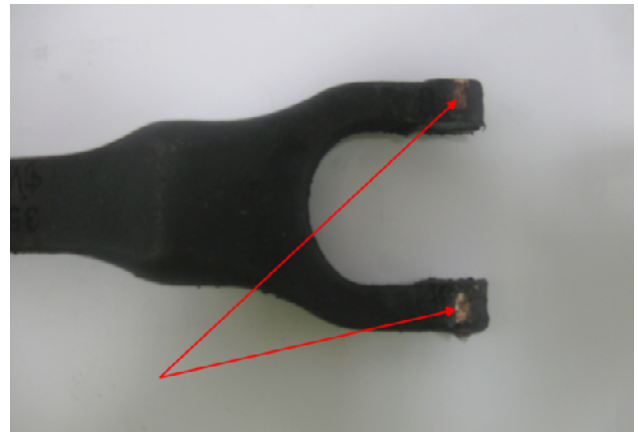
In these particular vehicles it has been identified that insufficient or no lubrication of the clutch release fork and pivot ball can result in a noise coming from within the bellhousing. This noise has often been incorrectly diagnosed as a faulty Thrust Bearing. Following the next few steps will help in overcoming this noise.

1. When the gearbox has been removed the clutch release fork needs to be thoroughly cleaned to remove any old grease.
2. Lubricate following areas on the Clutch Fork (see picture) with ClutchPro grease SPG3.
